John Gladding House & Store

205 & 211 Thames Street
Bristol, Rhode Island

CONDITIONS ASSESSMENT & FEASIBILITY STUDY

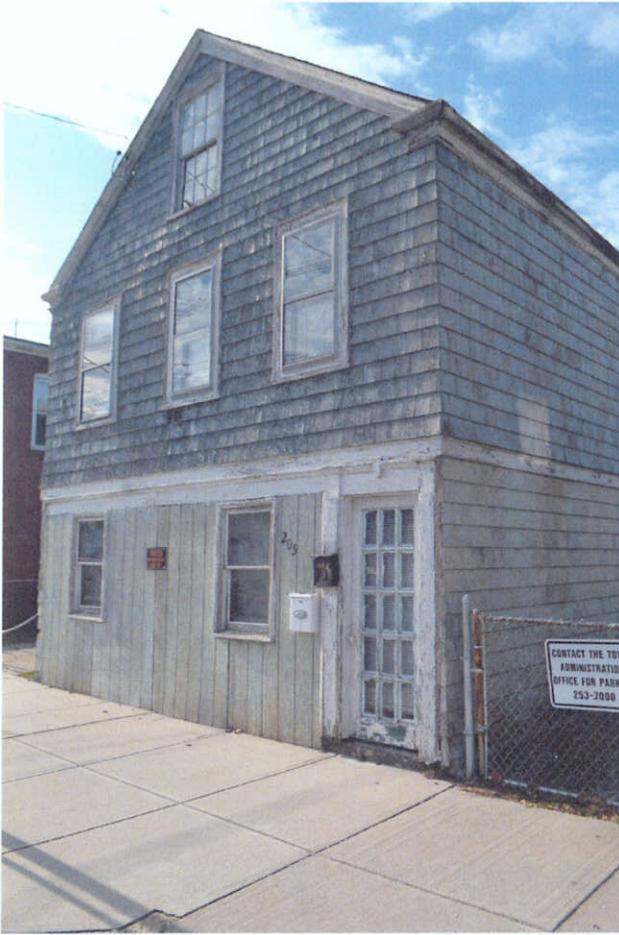
Test areas and photographic evidence revealed an original windowed storefront on the front first floor with central entrance (now removed and replaced with a studded wall and plywood panel siding with faux embossed boards.

Image 0744 Front (East) facade: location where original windowed storefront on the first floor with central entrance existed (now removed and replaced with a studded wall and plywood panel siding with faux embossed boards).

Fair Serious consideration should be made to remove a 1970s studded wall with plywood panel siding on the front and rebuild the front first floor windowed storefront with central entrance. In addition to this, on the rear section of the structure, three bays of windows (likely removed for the addition of two story porch) should be added to the first and second floors.

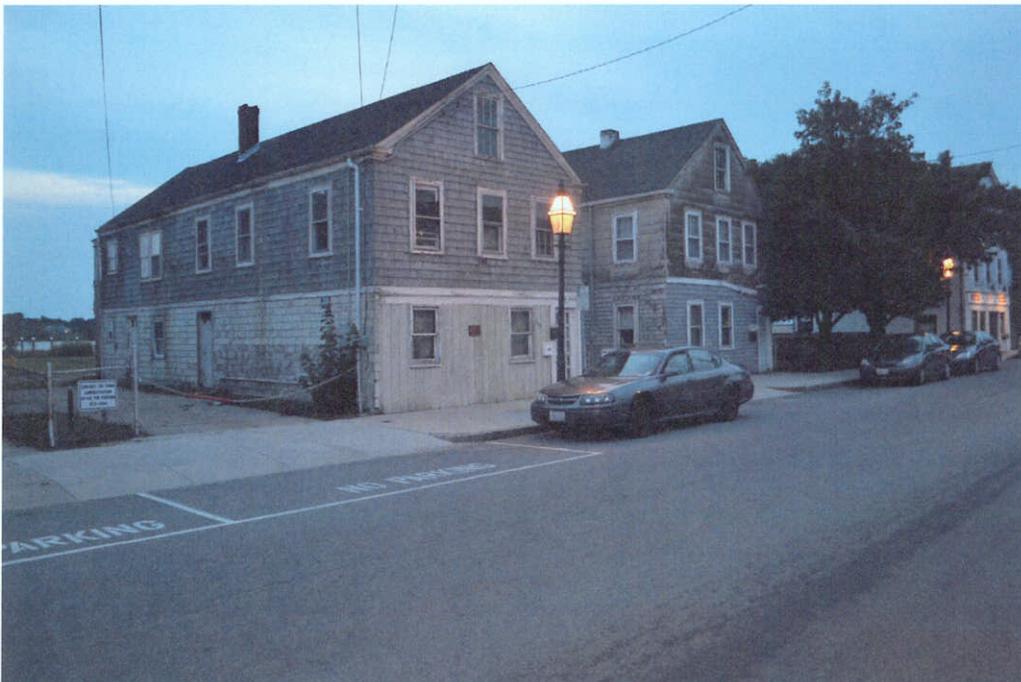
A single brick chimney on the south side is in poor condition. The mortar joints are eroded and there are missing bricks at the top but brick conditions appear good. There is no cap on the chimney. Flashing at the base seems intact. There was no evidence of leaking from within the garret.

The asphalt shingles on the structure are in severe condition. It was undeterminable how many layers of asphalt shingles exist. Wood failure exists on the gutters.

Image 1406 South & East view. Note chimney that is missing bricks and poor roof conditions. The empty lot to the left once had a narrow structure in close proximity to the property under investigation.

Severe	Replace missing bricks and repoint mortar joints. Install cap on chimney.
Severe	Investigate conditions from roof to confirm no new leaking is occurring and joints are closed.

Severe Remove all layers of existing asphalt shingles and reroof structure per manufactures instructions. Roof substrates (decking) appears to be in fair condition but may require the installation of an additional layer of 3/8" minimum exterior-grade plywood on top of the original decking. Given John Gladding's profession as a tin roofer, it is likely the roof was originally tin and should be explored as an option.

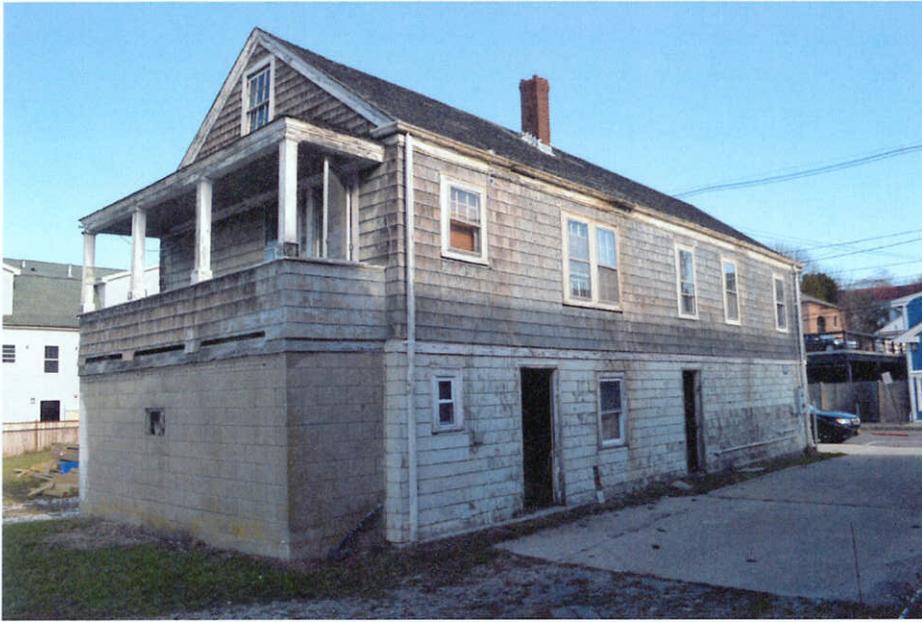
Image 1056 West & South facades with rear c. 1930s porch and the addition of exterior doors and kitchen and bathroom windows to the rear.

Critical The decking on the second floor rear porch is unsafe. Consideration should be made to remove the porch entirely and replace with a new contemporary porch design more in harmony with the structure's original dimensions/lines.

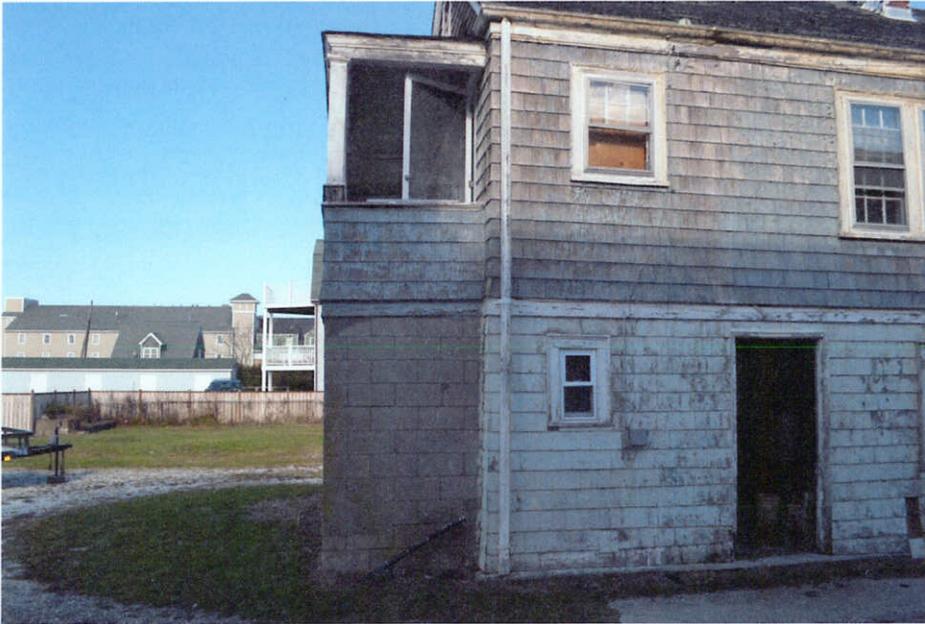
Image 1054 Side view of rear porch showing cement block addition to first floor and kitchen (2nd floor) and bathroom (first floor) windows. Note Areas of rotted gutter ends and cornice work.

Severe Areas of rotted gutter ends and cornice work should be identified and repaired in-kind and painted. Loose trim should be repaired with epoxy and in-kind materials and painted.

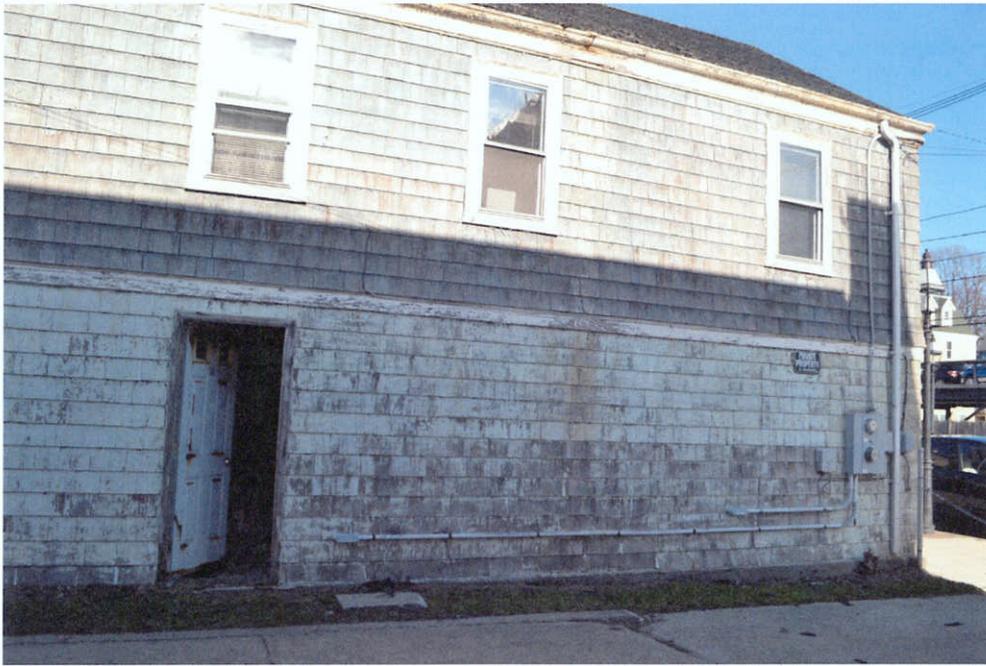
The exterior siding is in poor condition and suffers significant paint build-up and loss throughout. The current wood shingle siding is not original and likely dates to the 1930s or 1950s. The flare design separating the first and second floor is reminiscent of a feature found on many two-family houses at this time. Maintaining paint coatings is important to the protection of the wood from moisture penetration. The plywood panel siding with faux embossed boards on the front also suffers from paint loss. The decking on the second floor rear porch shows signs of structural failure.

Image 1048 South view Paint build-up and loss is found throughout the wood shingles on the facade and contains lead. The shakes are not original to the structure and consideration should be made to remove them using appropriate lead mitigation methods and replace with clapboards.

Severe Paint build-up and loss is found throughout the wood shingles on the facade and contains lead. The shakes are not original to the structure and

consideration should be made to remove them using appropriate lead mitigation methods, identify areas of sheathing failure and patch, investigate condition of sills, studs, and corner posts and repair where necessary, and replace exterior with appropriate wood clapboard siding and paint per manufacturers instructions.

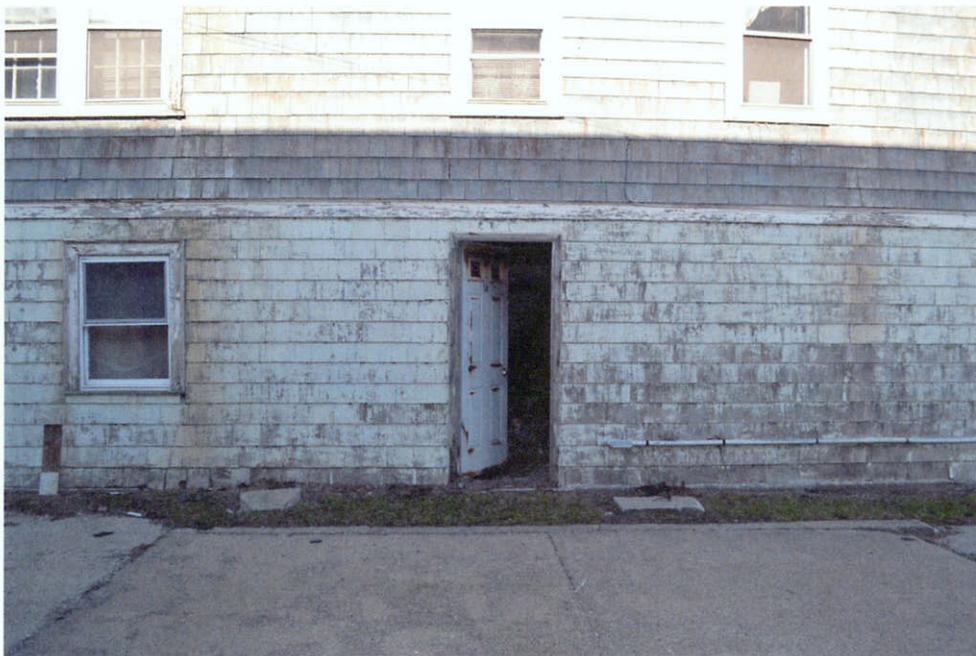
Contemporary linoleum windows appear to be in fair condition. All exterior doors are in poor condition, not original or character defining, and vary in material from wood to steel.

Image 1052 showing failing paint condition contemporary exterior door and vinyl window additions and poured concrete slab with concrete 8" curb wall that acts as the foundation.

Severe Remove existing doors and replace with appropriate wood doors.

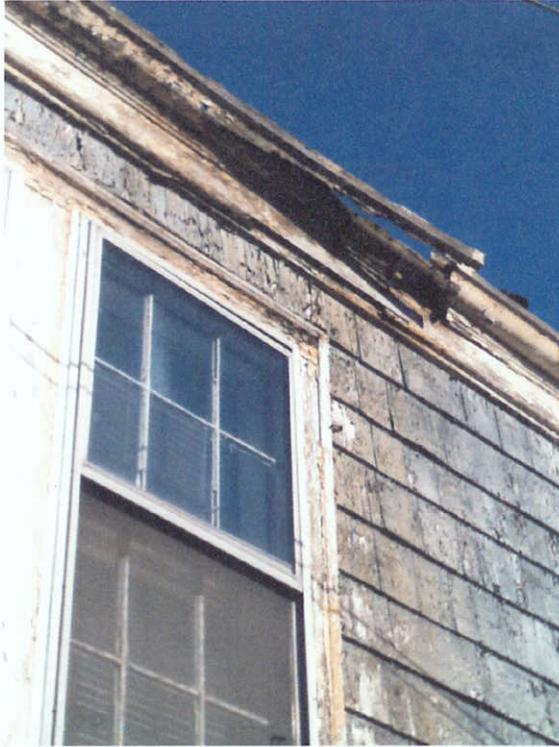
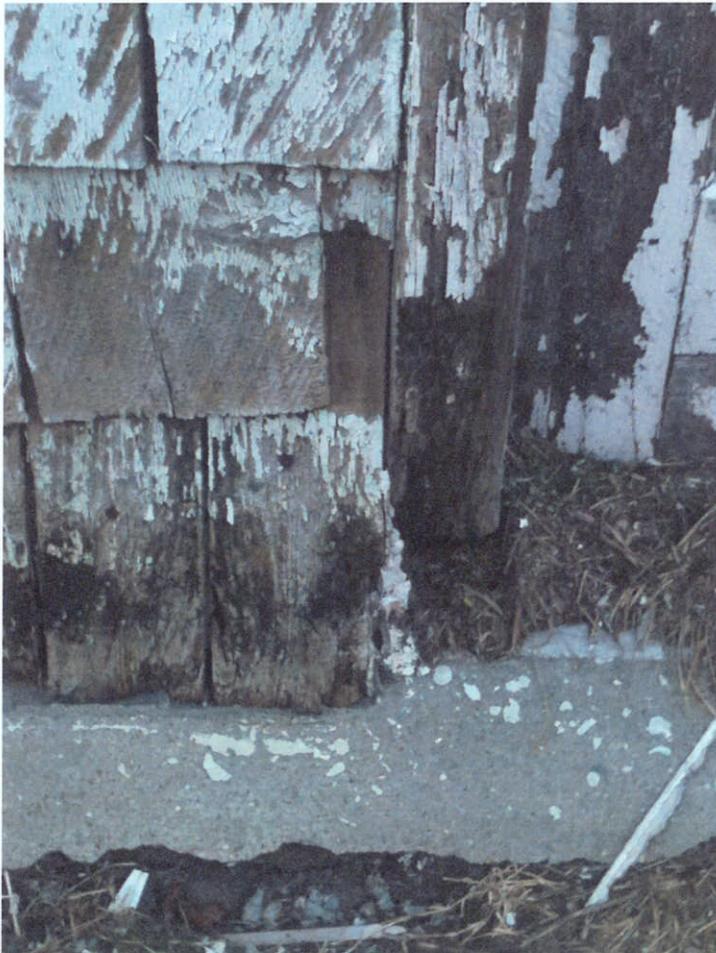
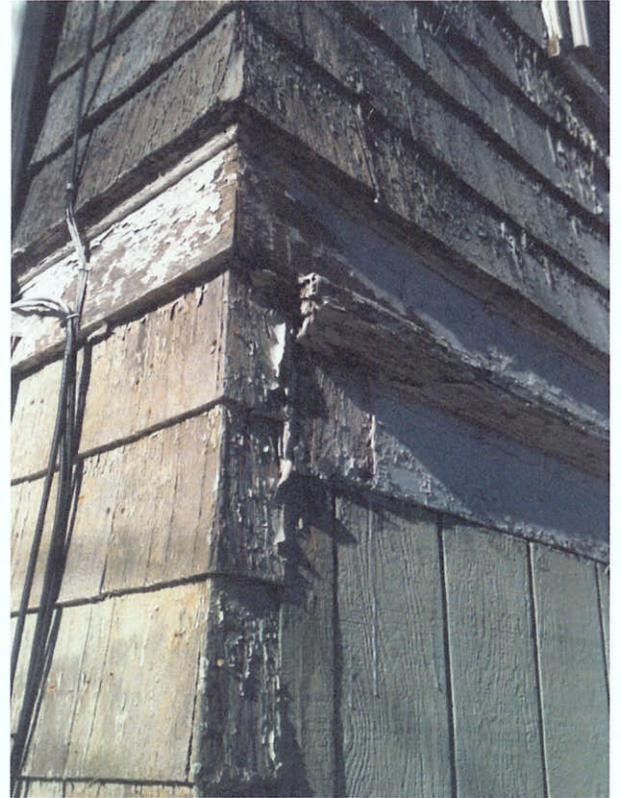
Areas of significant paint loss and wood failure are found throughout. **Image 101** (top left) is a detail of the south cornice and gutter system, **Image 102** (left) is a detail of the wood shakes that meet the 20th century cement curb wall. **Image 103** (right) shows the flare design along with area that originally contained the front store windows.

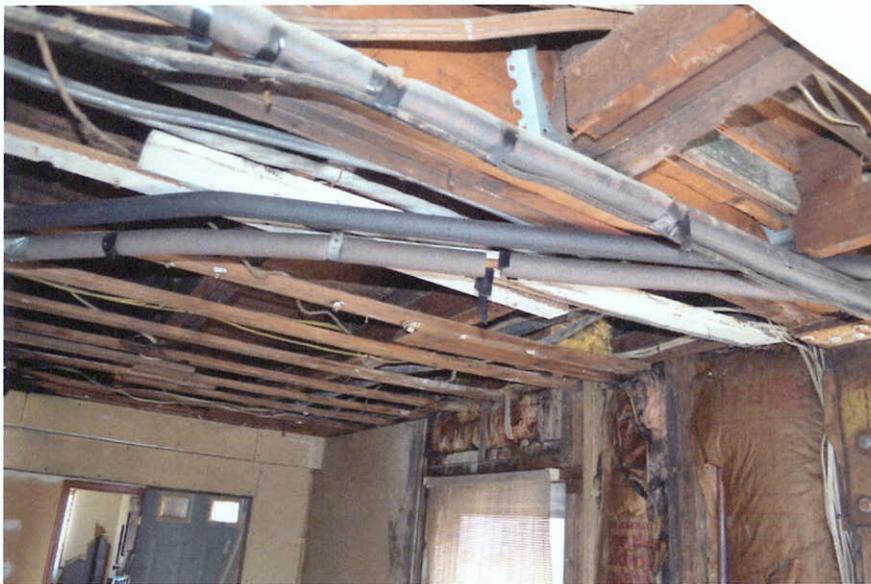
Image 0019 Detail of 20th century repairs made to original exposed chamfered post and beams and many archaic electric and plumbing additions.

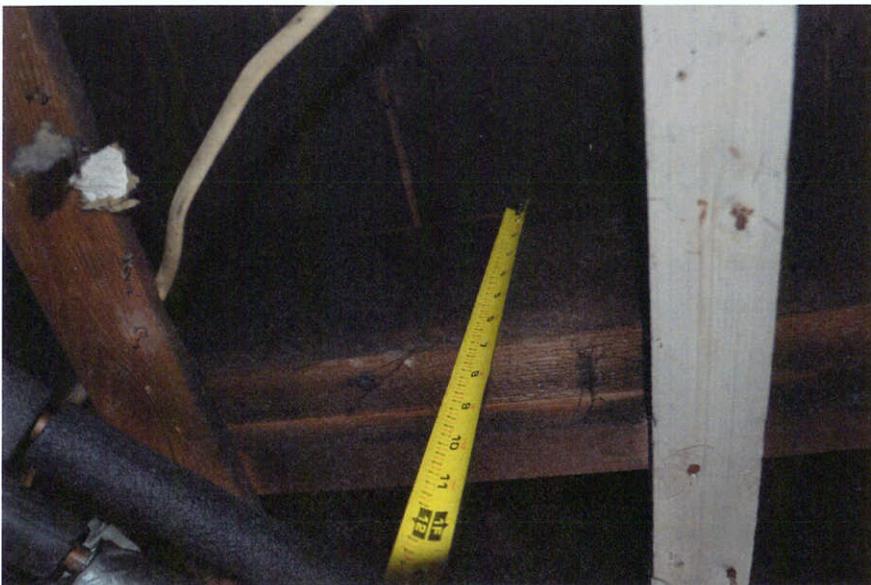
Image 0023 In some areas 7" joists were added for support to the second floor. Strapping was also added and the original exposed chamfered beams were encased under drop ceilings.

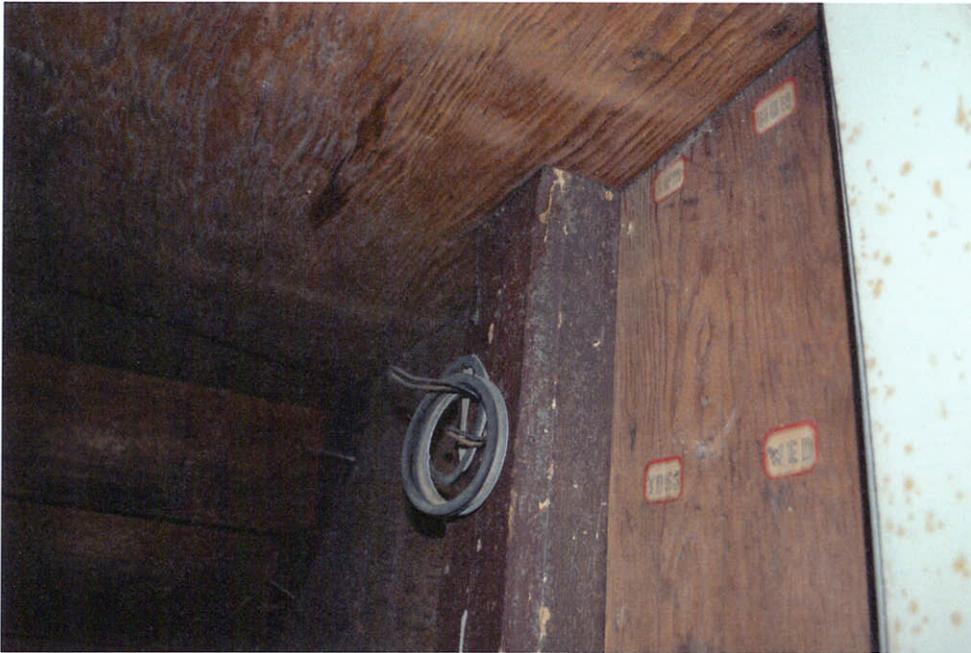
Image 0037 Detail of one of the original chamfered posts found under the front stairs. The layout appears to have been an open concept supported by handsome chamfered wood posts and beams, typical of mid-19th century shop interiors.

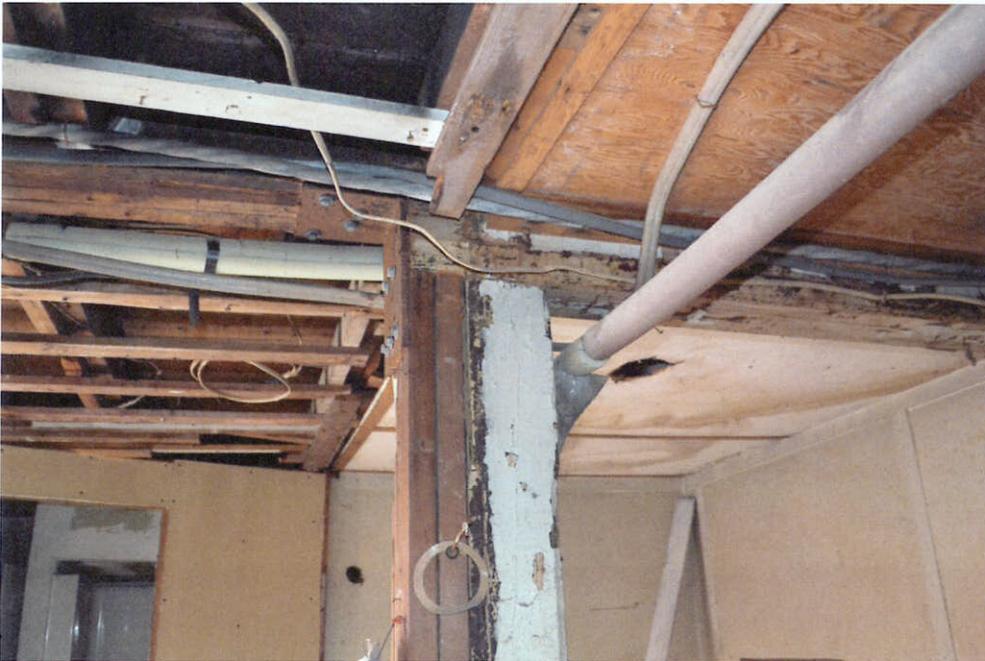
Image 0056 exposed original chamfered wood post and beam with 20th century sistering with iron bracket and 7" joists were original chamfered beam would have been located.

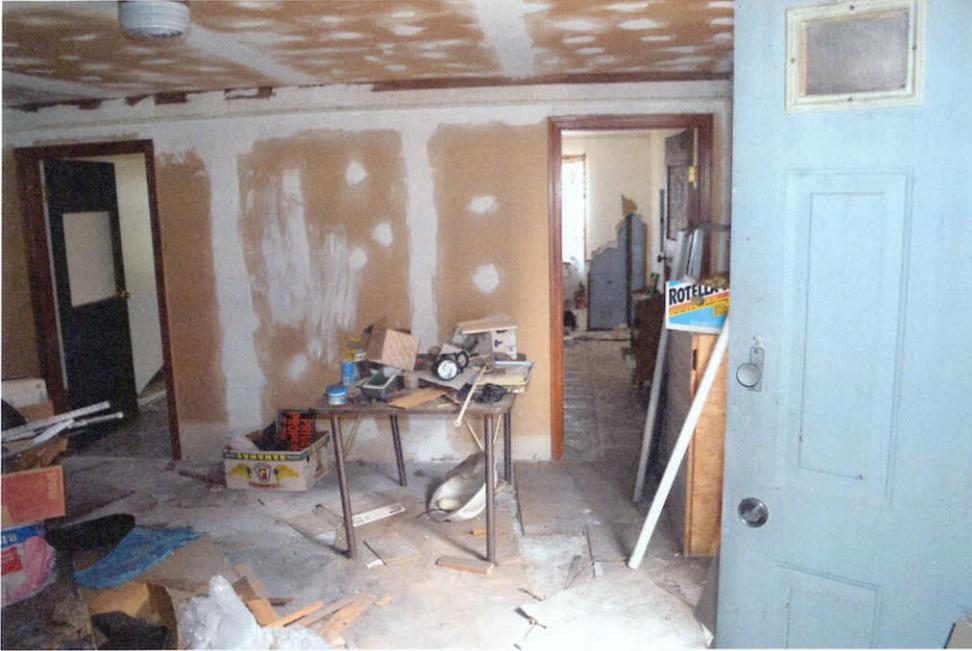
Image 0025 Newer partitions are found throughout the first floor from a failed rehab . The partitions divide up the original open store space into domestic rooms eg bedrooms, bathroom, etc.

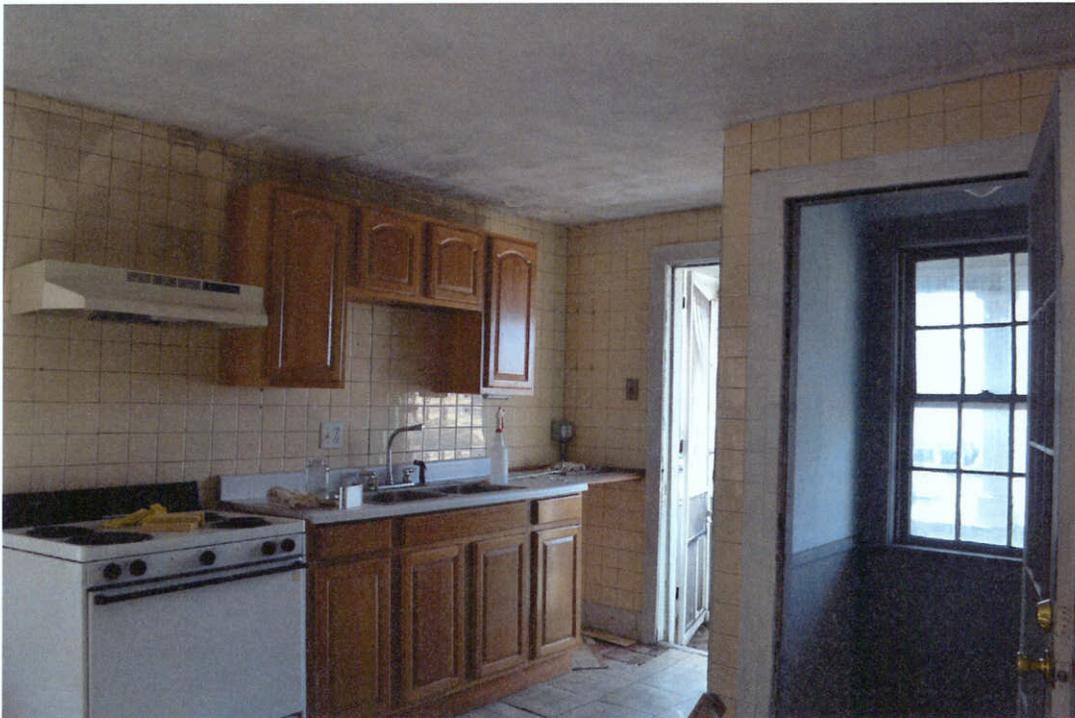
Image 0077 A modern kitchen was added to the rear second floor and is tiled throughout the space with contemporary ceramic.

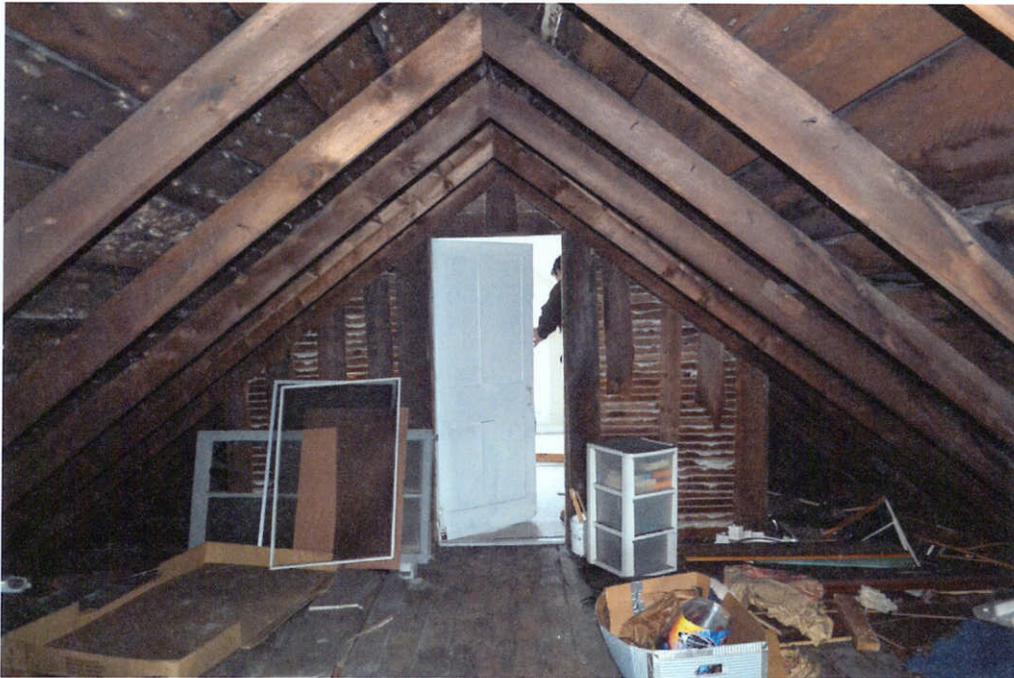
Image 0101 The middle room in the attic is unfinished and reveals the construction method of the roof. All framing appears to be in fair condition.

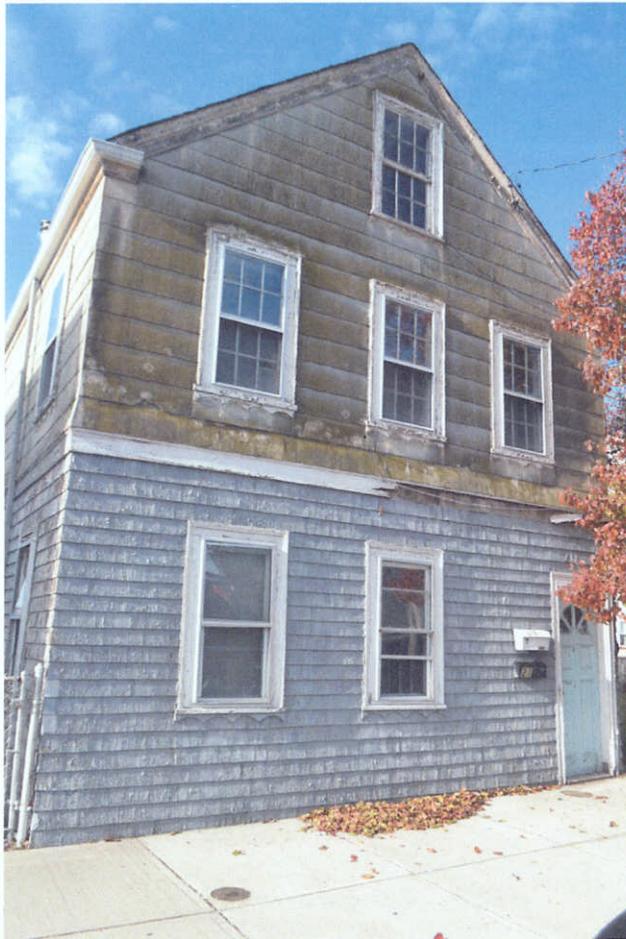
Image 0746 Front (East) facade. Exterior siding is in poor condition and suffers significant paint loss. The first floor has wood shingle siding that is not original and likely dates to the 1930s or 1950s. Note the flare design separating the first and second floor. The second floor and garret areas are clad in asbestos shingle siding. An unusual scalloped detail (c.1950s) is found under the window trim. Original windows remain on second and third floors.

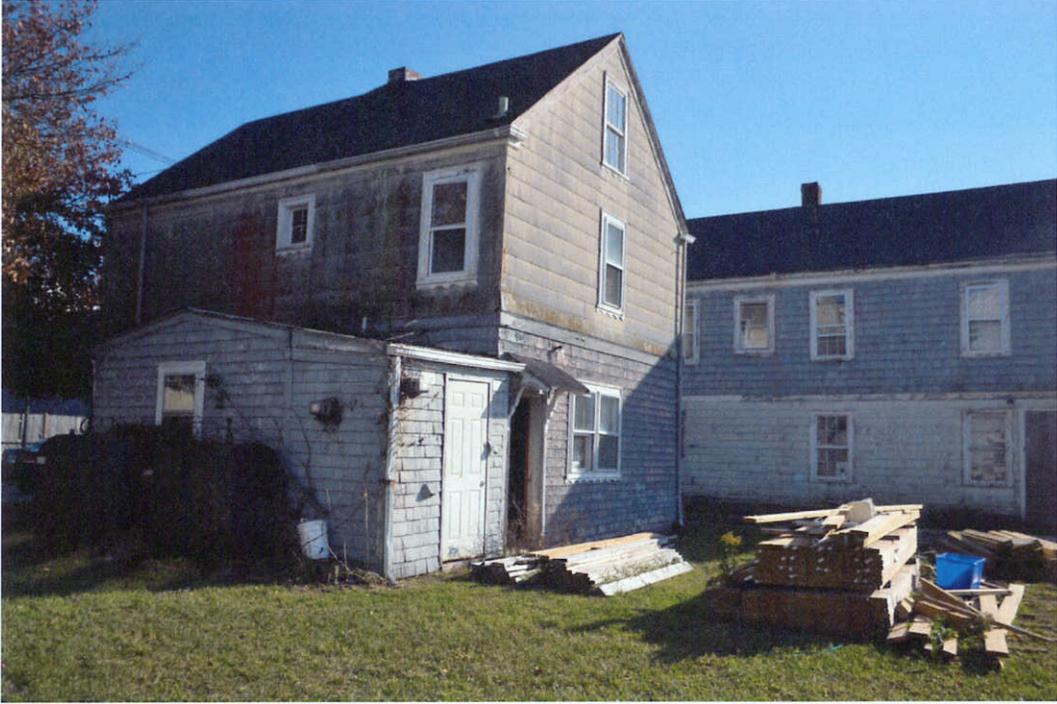
Image 0209 View of West and North elevations with mid-20th century addition. Windows on these elevations (excluding garret) have vinyl replacement windows).

Fair Contemporary linoleum windows should be removed and replaced with new 6/6 double hung wood sash windows with similar muntin size to historic versions at site. The double linoleum window on the first floor rear should be removed and converted to a single 6/6 double hung wood sash window.

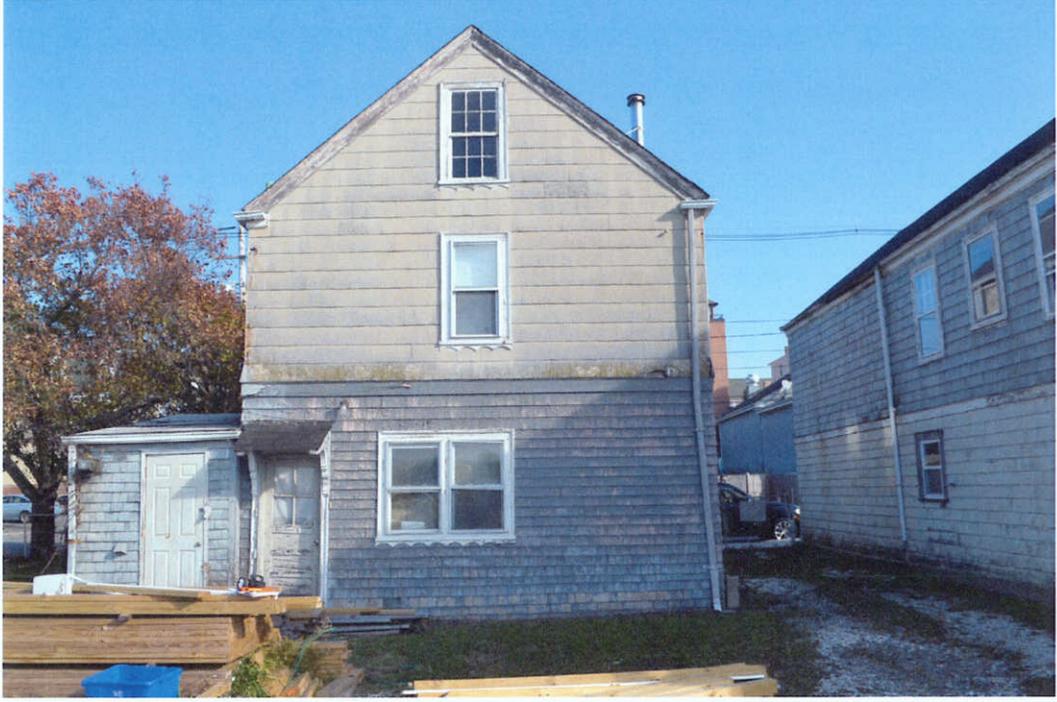
Image 0124 Rear (West) elevation. Note the significant bulging on the bottom right of the structure in this image and poor condition on the addition to the left. It appears the double windows on the first floor are not original.

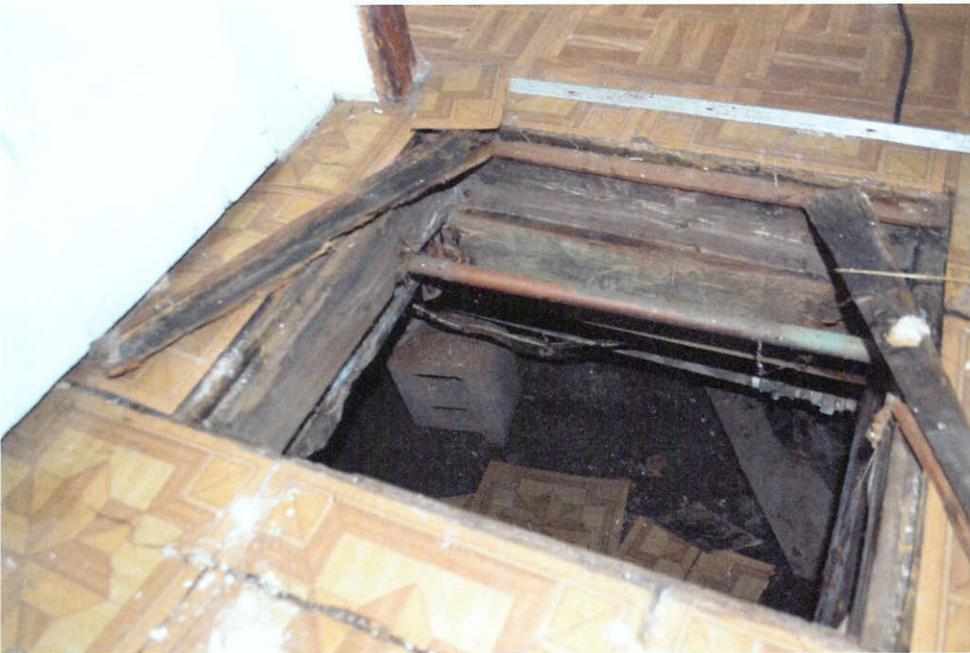
Image 0199 Access to a crawl space was discovered during a site visit which revealed the current state of the fieldstone foundation, floor joists, and subfloor: considerable moisture and wood failure. The current first floor is not considered safe due to considerable flex (spongy) when walked on.

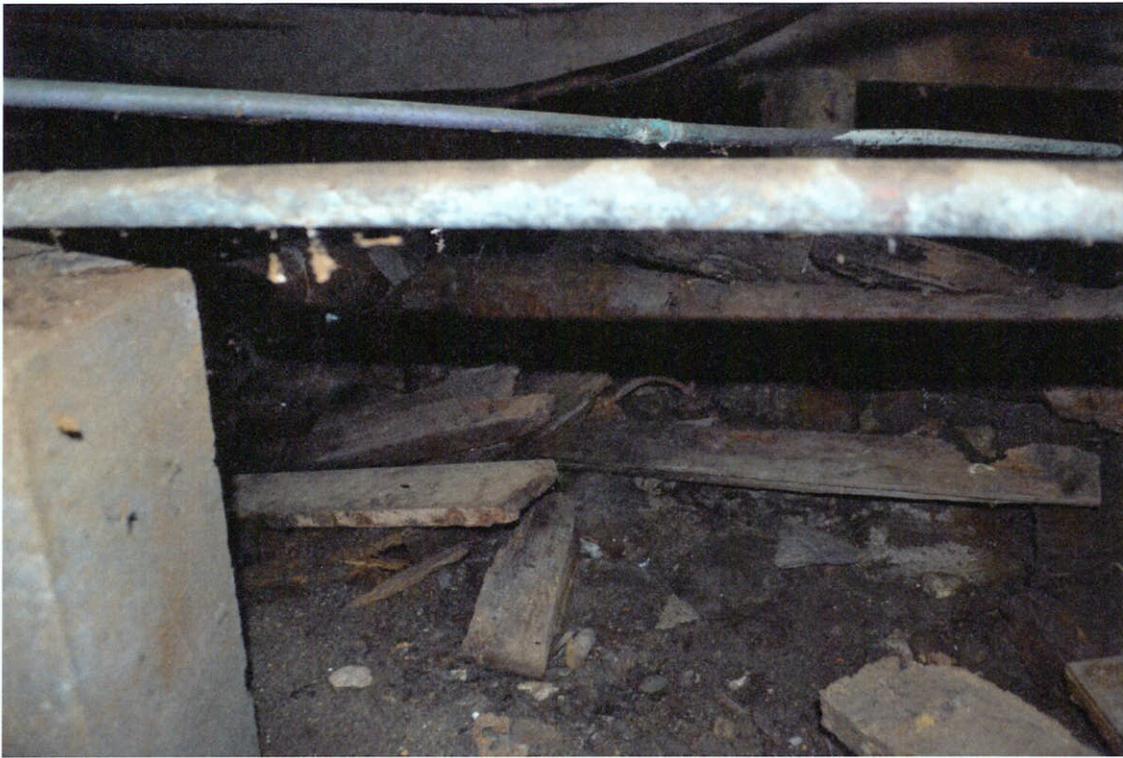
Image 0190
Crawlspace
showing dirt
floor and failing
subfloor

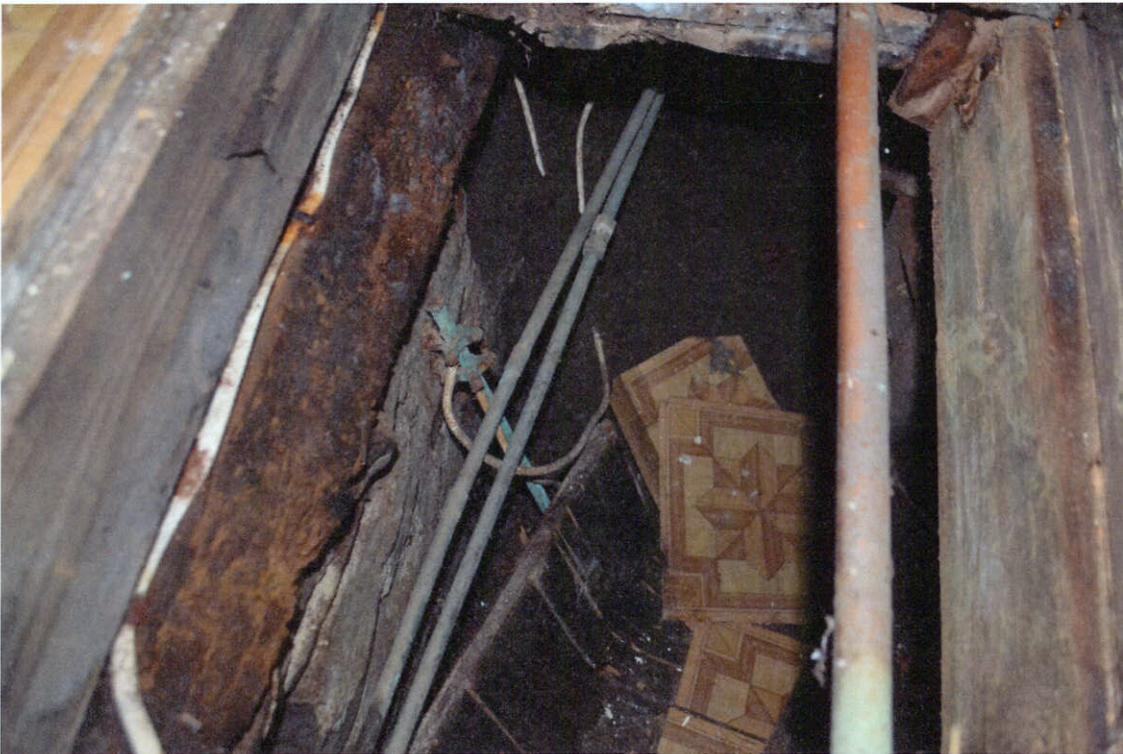
Image 0154
Crawlspace
showing mold
and wood failure
on sills.

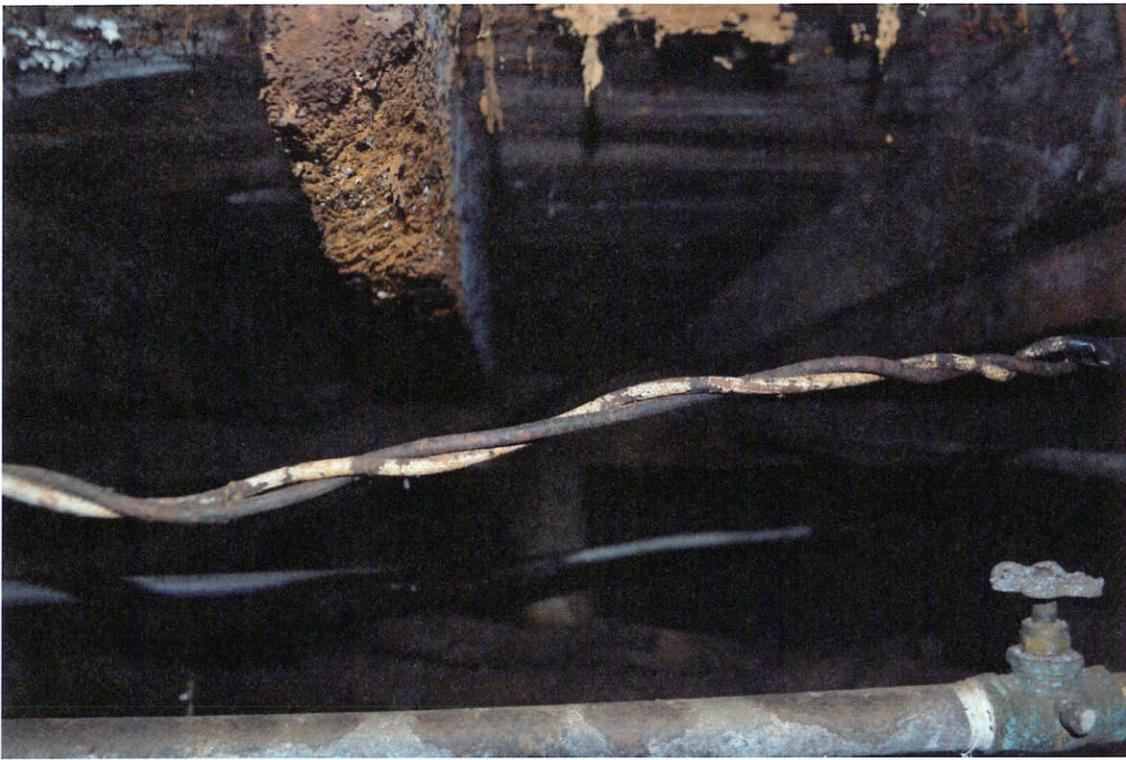
Image 0185
Crawlspace detailing mold, failing subfloor, joists, and supports.

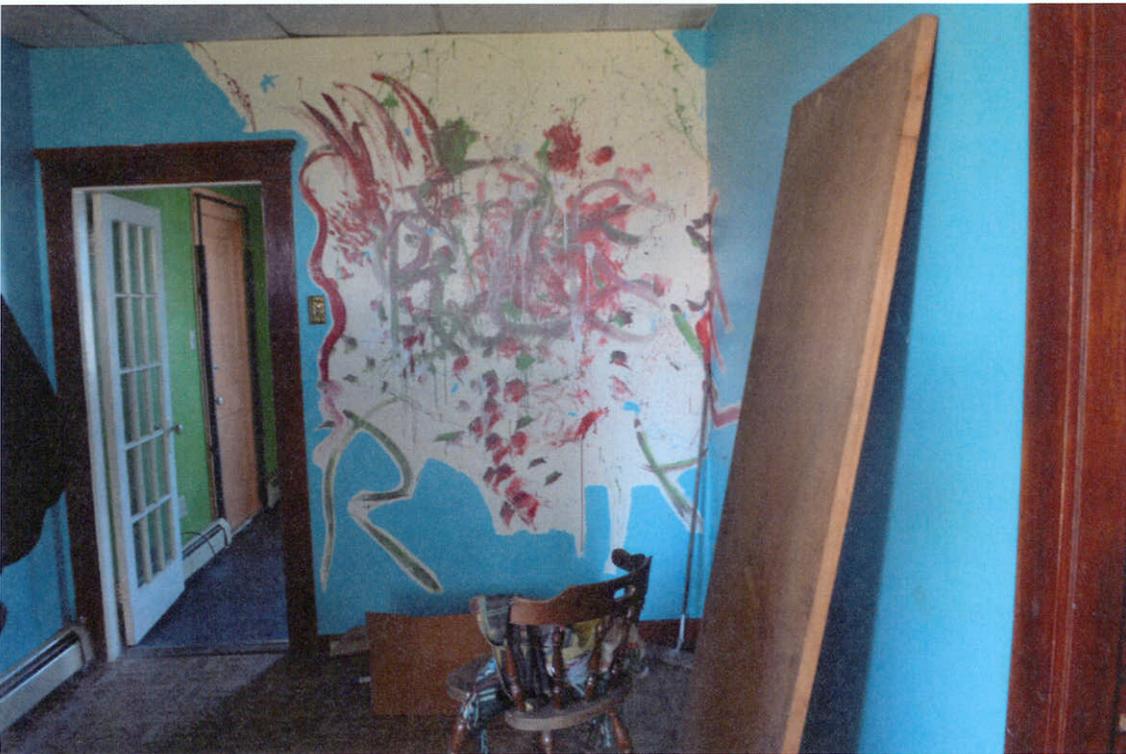
Image 0146
Interior finishes throughout were not deemed character defining features and were in poor condition due to extensive moisture problems and mold growth.

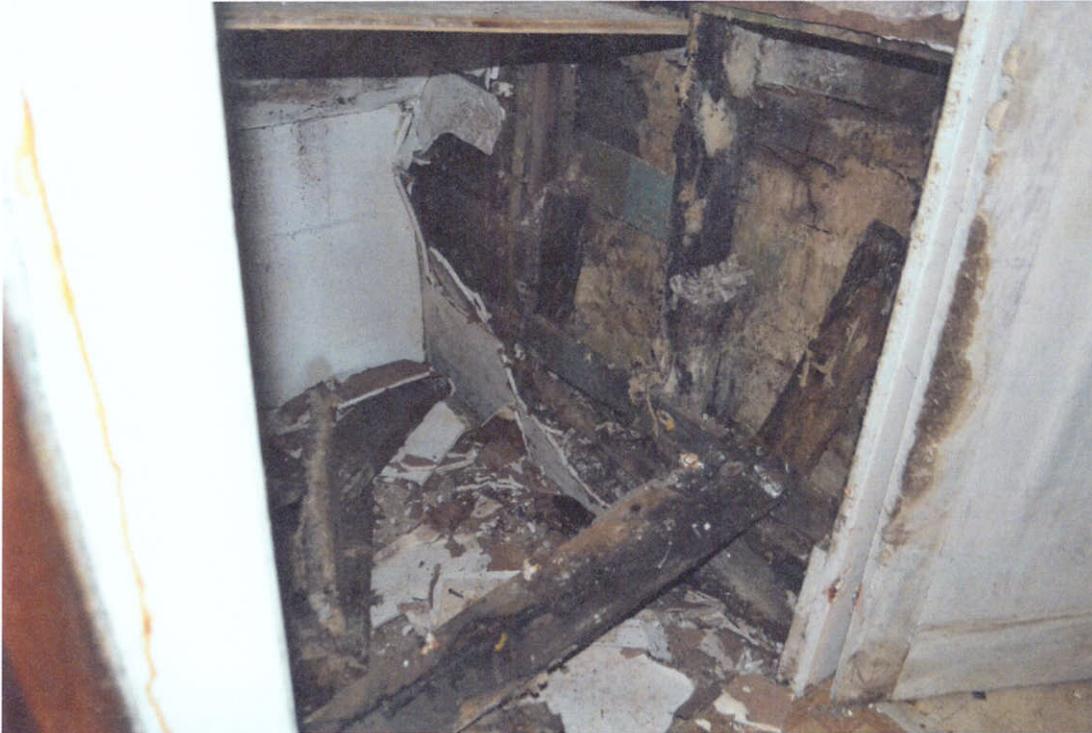
Image 0149

Test area to determine condition of exterior walls. Note extensive wood failure in studs and sill, moisture problems, and considerable mold growth.

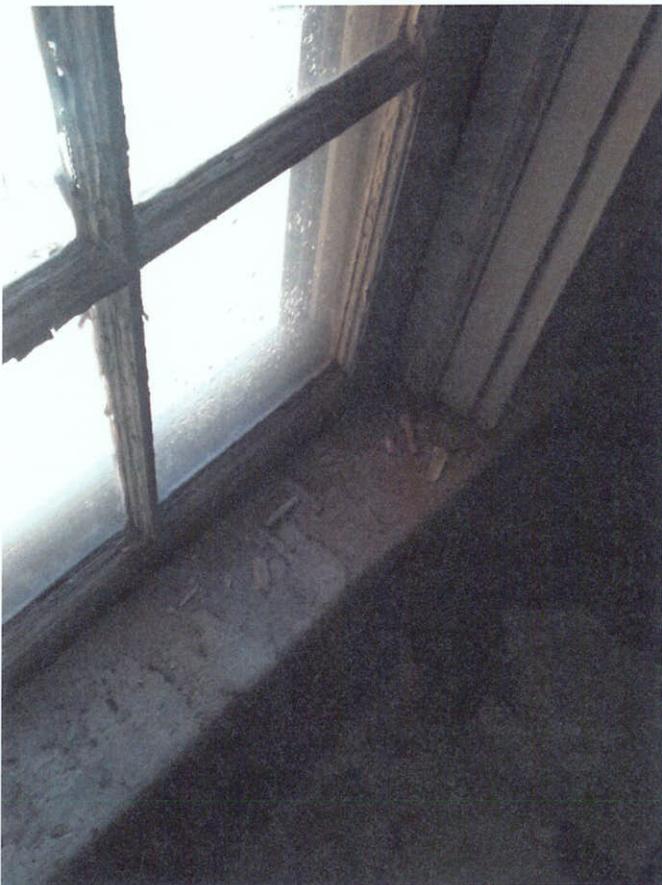
Image 201 Many original 6/6 double hung wood sash windows remain intact on the second and third floor but all exhibit glazing and paint failure and missing/damaged hardware. Current storm windows (where found) offer some protection but are in poor condition. Note the significant moisture problems found throughout the structure.

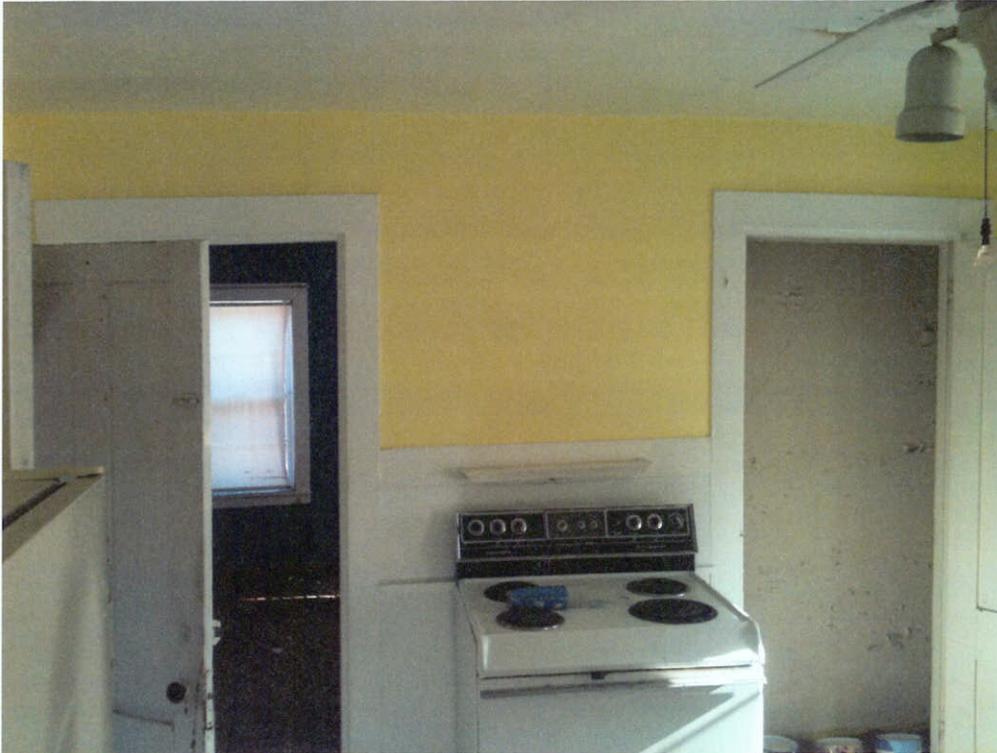
Image 202
Significant settling away from the chimney stack in all directions was observed on the second floor. The chimney stack is located behind this contemporary electric stove. Note the angles pushing down away from the chimney stack on the casework.
