John Gladding House & Store

205 & 211 Thames Street
Bristol, Rhode Island

CONDITIONS ASSESSMENT & FEASIBILITY STUDY

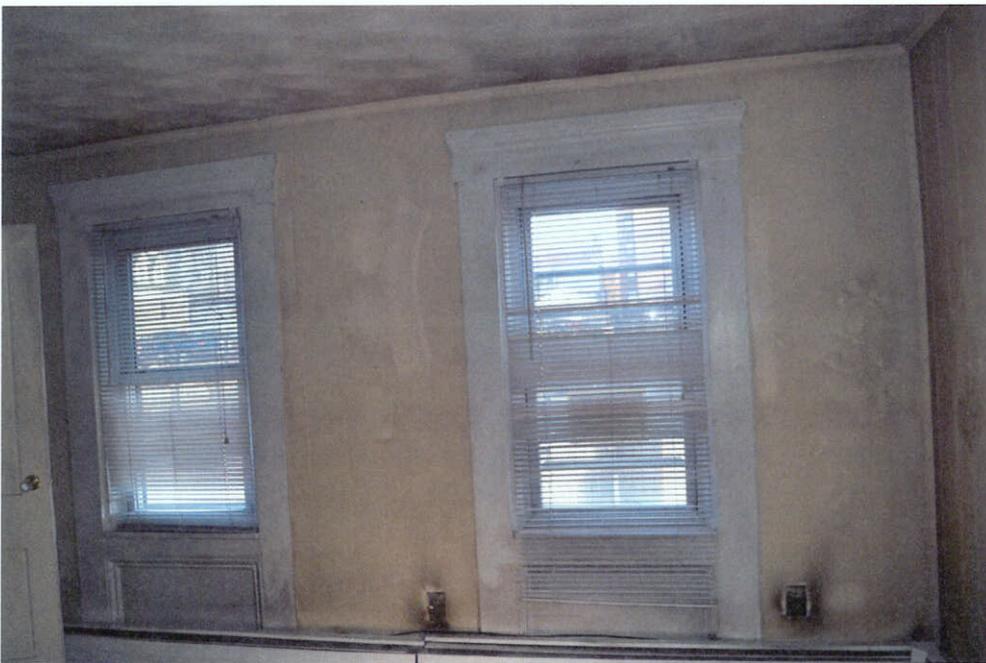
Image 0115 The second floor retains a high degree of integrity as to its original layout and design. Original finishes in the Greek Revival-style remain intact on doorway trim, window trim with paneled aprons in the front.

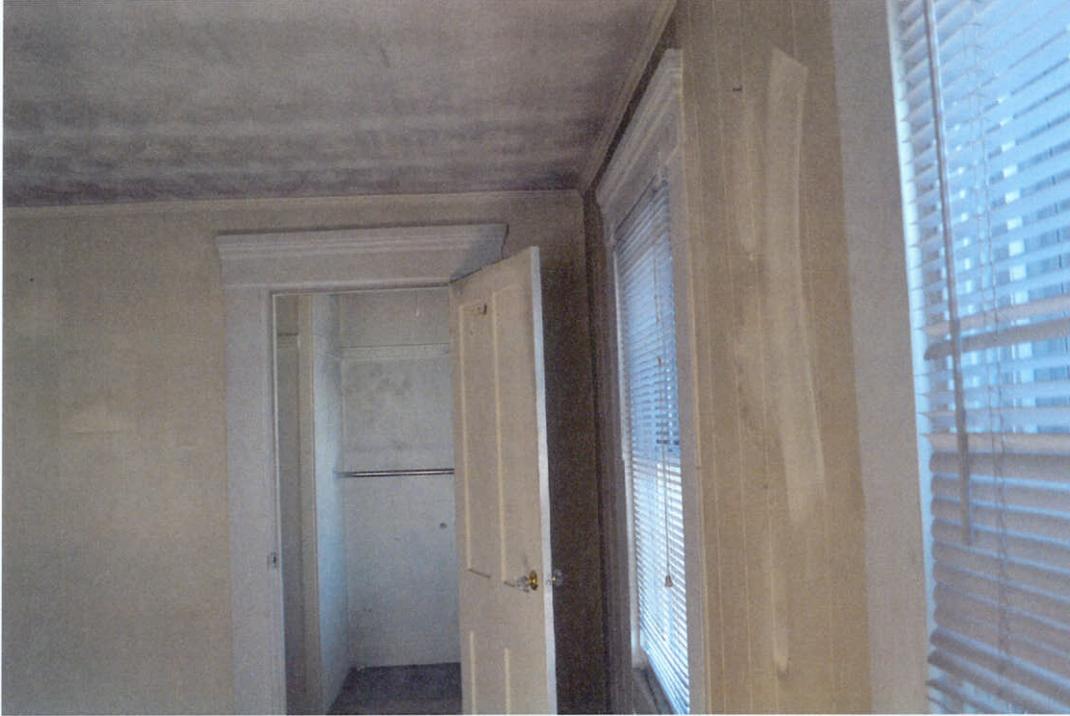
Image 0113 The second floor retains a high degree of integrity as to its original layout and design. Original finishes in the Greek Revival-style remain intact on doorway trim, window trim with paneled aprons in the front.

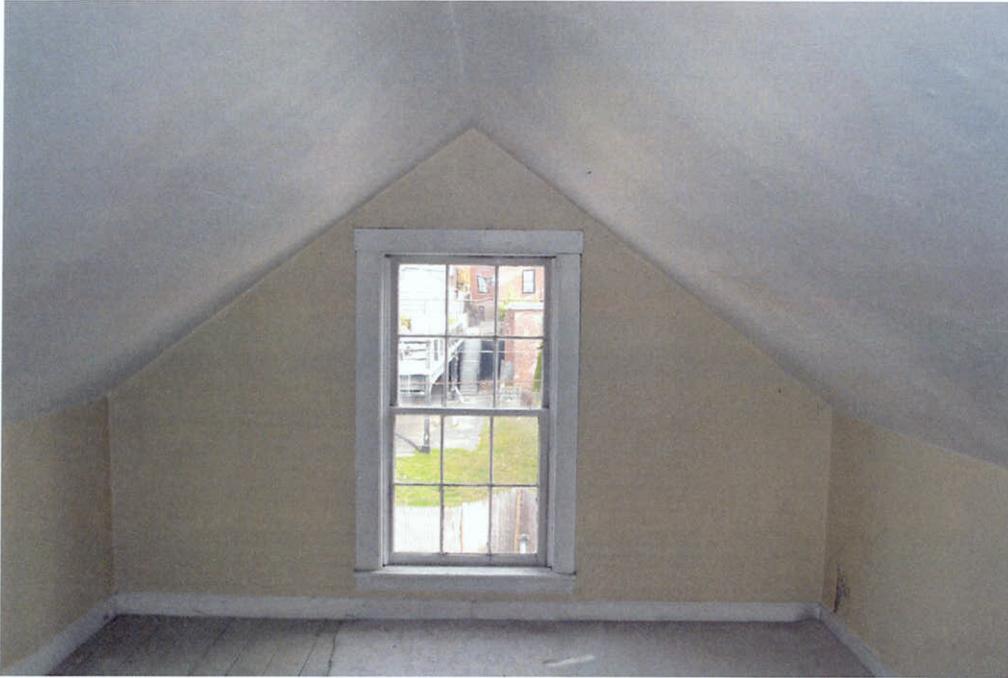
Image 0085 Two finished rooms exist in the garret and contain original 6/6 double sash wood windows.
